Application of the OSOM+ Systematic Observation Methodology to Maritime Structures at the Port of Sines

R. Capitão^{a,*}, C.J.E.M. Fortes^a, R. Lemos^a, M.J. Henriques^a and L.G. Silva^a
^aLNEC - National Laboratory for Civil Engineering, Lisbon, Portugal

This paper compares the results of inspection campaigns conducted in 2018, 2020, 2022, and 2023 on the west breakwater, based on visual inspections and drone surveys, and supported by a critical analysis of georeferenced photographs, orthomosaics, point clouds, digital surface models, and cross-sectional profiles.

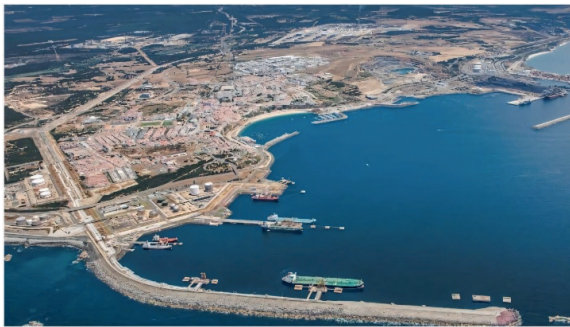
Figure 1. The Port of Sines

The Port of Sines is the largest artificial harbour in Portugal, operating as a deep-water port with natural bathymetries reaching depths of up to -28 m CD (Chart Datum), as shown in Fig. 1. Owing to its strategic geophysical characteristics, it serves as Portugal's main maritime gateway for energy supply, handling the import and export of containers, liquefied natural gas, coal, crude oil, and petroleum derivatives.

Among these, the west breakwater is the case study presented in this paper (outlined in yellow in the figure, while the remaining structures are shown in red). This breakwater suffered severe storm damage during 1978 and 1979, with progressive failure episodes that fractured and displaced large dolos armour units and undermined the superstructure, ultimately leading to extensive reconstruction works (Reis et al., 2011). Subsequent repair interventions included the use of heavy Antifer-type cubes on widened sections and gentler slopes, followed by a final redesign to meet updated 100-year return-period sea states. These interventions highlighted the importance of armour unit mechanical strength limits, placement density, and the risks associated with storm climate underestimation. Such lessons are consistent with broader assessments of concrete armour integrity, which emphasise size-effect fragility and the need for structural and hydraulic verification beyond notional stability numbers (Scaravaglione et al., 2022; Leone et al.,

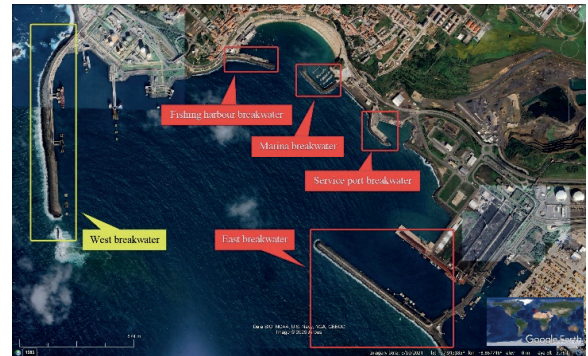
Figure 2. Rubble-mound breakwaters at the port of Sines

All breakwaters at Sines are monitored under the OSOM+ programme, including the west breakwater, the east breakwater, the marina breakwater, the fishing harbour breakwater, and the service port breakwater (see Fig. 2).

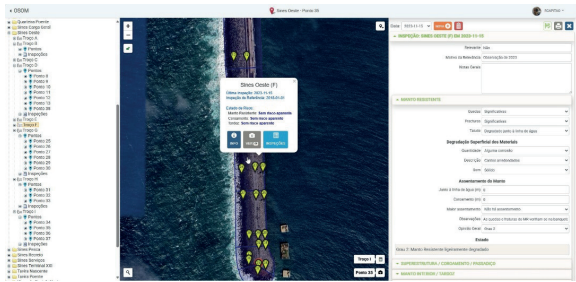
Figure 3. ANOSOM-WEB interface showing the west breakwater of the Port of Sines

More recently, the development of the ANOSOM-WEB interface has introduced a web-based GIS platform accessible from any internet-connected device (smartphone, tablet, or computer). During field campaigns, inspectors can use this platform to review data from previous inspections, access real-time condition assessments, and determine whether immediate intervention is required (Fig. 3).

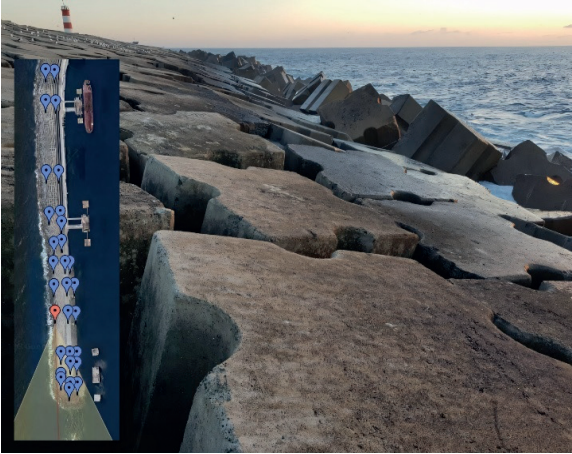
Figure 6. 2018 visual observation at point 27F (F – front direction) of the Sines west breakwater (outer armour layer)

Figures 6, 7, and 8 present photographs taken during the 2018, 2020, and 2022 inspection campaigns, respectively, at predefined observation points on the Sines west breakwater. These include point 27 on the seaward side of section G, point 28 on the harbour-side of section G, and point 37 at the breakwater head (section I). Comparisons between the 2018, 2020, and 2022 campaigns revealed some localized structural changes, which are illustrated in Figures 9 and 10. These figures show photographs from the locations where the most relevant changes were detected, namely section F at point 24 (Fig. 9) and section F at point 27 (Fig. 10). In both cases, block breakage was observed between successive inspection campaigns.

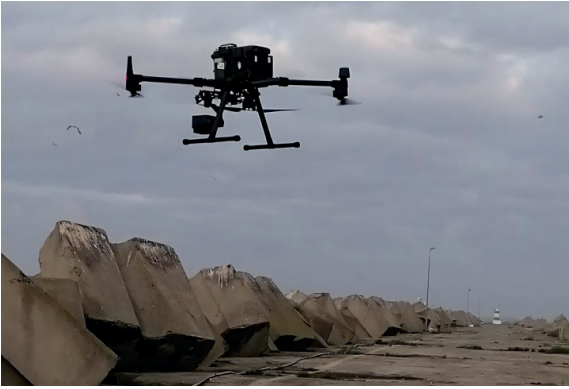
Figure 11. LNEC DJI Matrice 300 RTK UAV

For the aerial inspection of the structure, the required equipment consisted of an Unmanned Aerial Vehicle (UAV) system operated in conjunction with dedicated flight control and mission-planning software. The initial survey campaign, conducted in 2018, employed a DJI Inspire V1 platform equipped with a Zenmuse X3 camera (12 MP). In the subsequent campaigns of 2020 and 2022, the system was upgraded to a DJI Matrice 300 RTK fitted with a Zenmuse H20 payload (wide-angle and 20 MP zoom cameras with integrated laser rangefinder). This upgrade significantly improved flight stability, positional accuracy, and operational safety, particularly under moderate to strong wind conditions (Fig. 11).

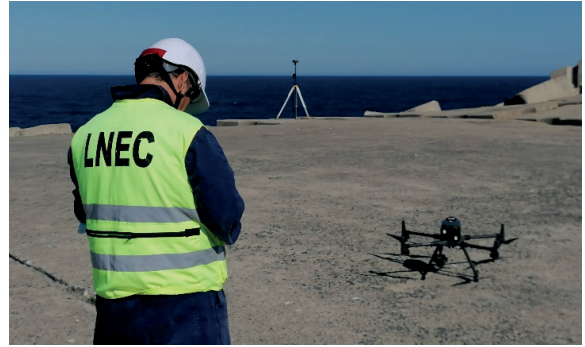
Figure 14. UAV operator preparing a flight on the Sines west breakwater; the RTK GNSS base antenna is visible at the top of the image

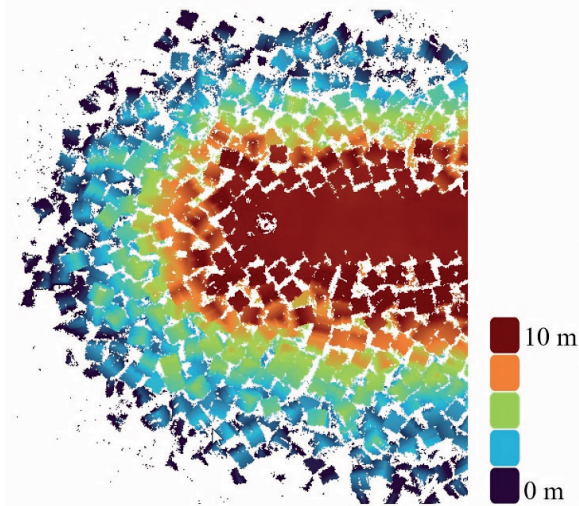
Figure 16. DSM (matrix representation) of the head section of the Sines west breakwater

The processing workflow followed a sequential procedure applied to each breakwater section and survey campaign: (i) generation of the dense point cloud; (ii) computation of the DSM and storage in matrix format (Fig. 16); and (iii) production of the orthomosaic (Fig. 17).

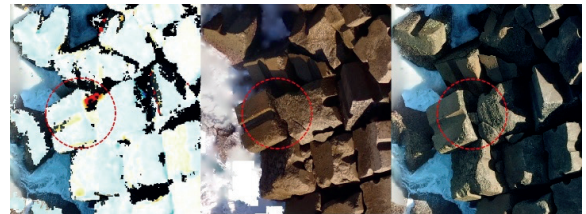
Figures 19 and 20 present, as examples, the maps of detected changes and the corresponding orthomosaics for 2020 and 2022 in sections where relevant modifications were identified. In the adopted colour scale, red indicates material loss, while blue represents material deposition. These analyses were carried out in QGIS, which also served as the primary platform for visualising orthomosaics and DSMs, owing to its robust capabilities for handling and displaying georeferenced raster data and for enhancing topographic features through colour manipulation.

Figure 19. West breakwater. Changes detected between 2020 and 2022 – Occurrence 2 – Section E
